## ***Airworthiness Directive 2012-21-51 Summary***

## **AIRWORTHINESS DIRECTIVE**

**AD #:** 2012-21-51

2012-21-51 **EUROCOPTER FRANCE:** Directorate Identifier 2012-SW-095-AD.

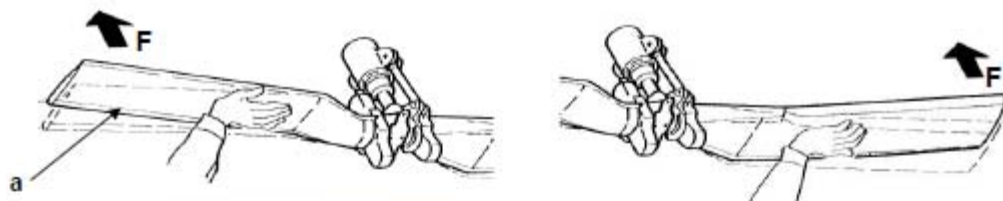
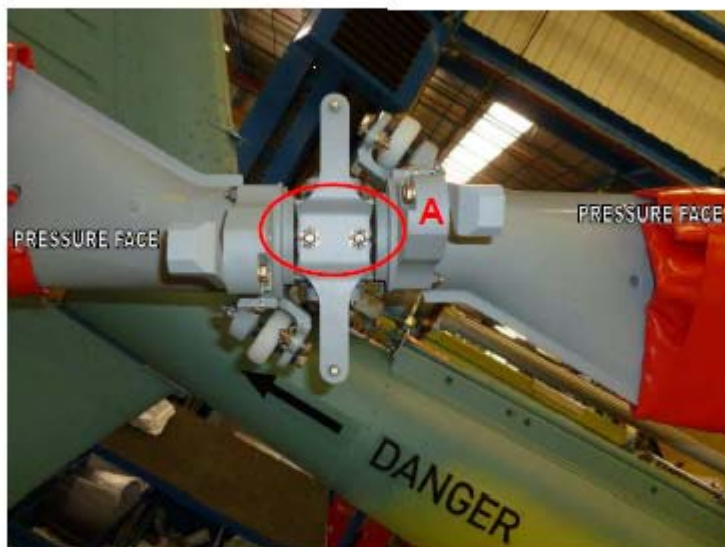
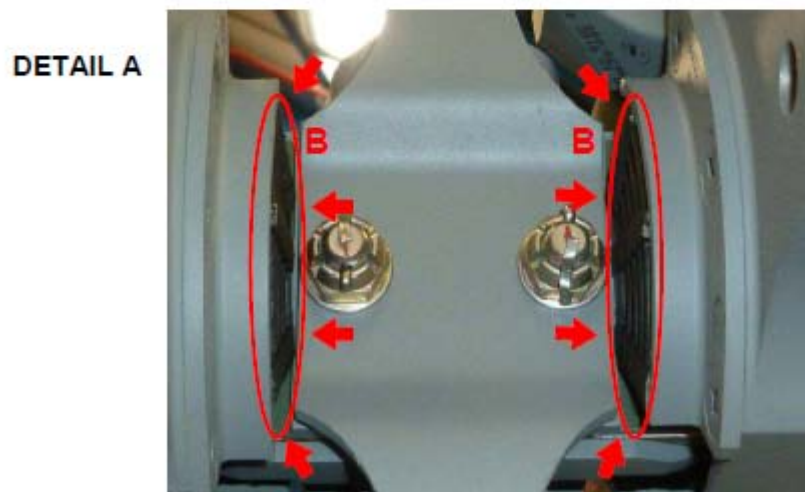
Figure 5 to paragraphs (e)(3)(ii) and (e)(3)(iii)

(iii) While maintaining the load, check all the visible faces of the bearings (front and side faces) in area B of DETAIL A of Figure 5 to paragraphs (e)(3)(i) and (e)(3)(iii) of this EAD for separation between the elastomer and metal parts, a crack in the elastomer, or an extrusion (see example in Figure 6 to paragraph (e)(3)(iii) of this EAD).

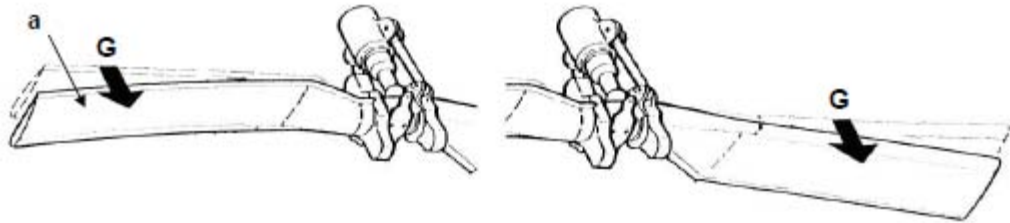
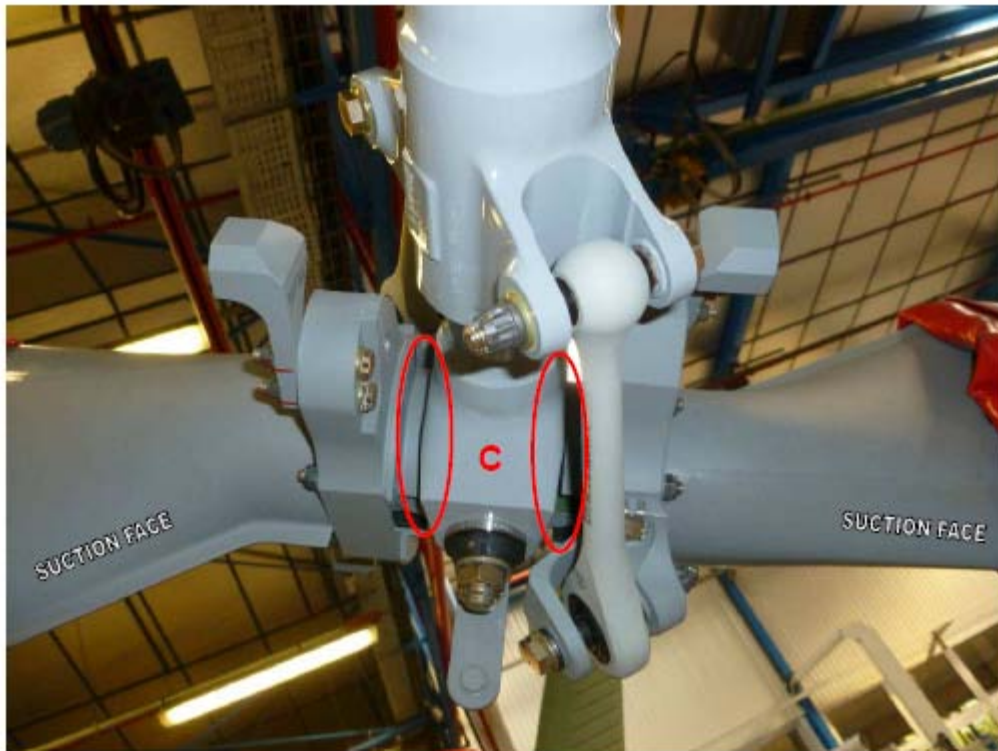
(vi) While maintaining the load, check visible faces of Area C as shown in Figure 7 to paragraphs (e)(3)(v) and (e)(3)(vi) of this EAD for any extrusion.

(5) If there is an extrusion on any bearing, before further flight, replace the four bearings with airworthy bearings.

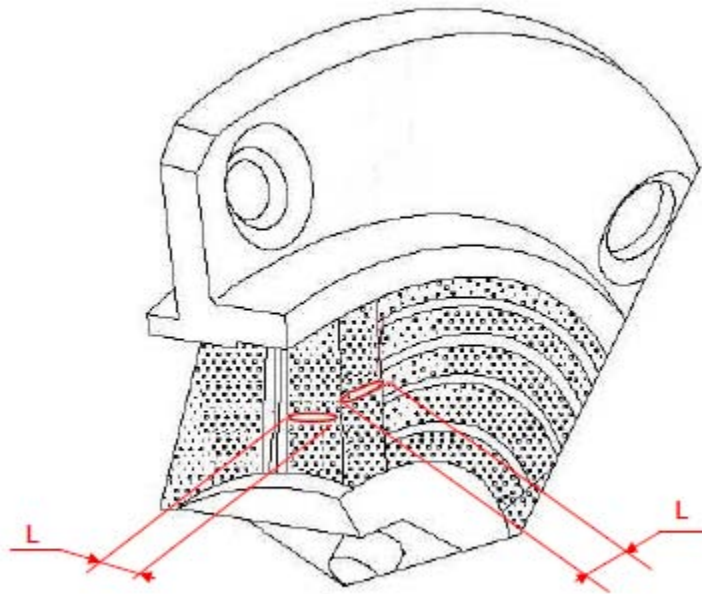
Figure 8 to paragraph (e)(6)

(6) If there is a separation or a crack on the pressure side bearing, measure the separation or the crack. If the separation or crack is greater than 5 millimeters (.196 inches) as indicated by dimension "L" in Figure 8 to paragraph (e)(6), before further flight, replace the four bearings with airworthy bearings.
